## Remote Keyless Entry Interference

### GM TECH *Link*

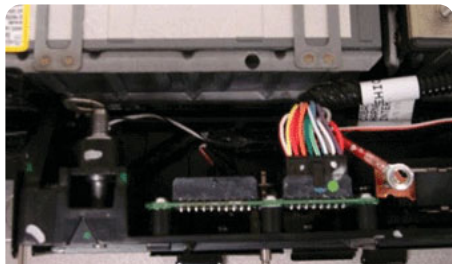
**If a DTC P0AF8 or P0AFB is setting, the connections at the BECM, contactor relay and disconnect switch should be checked.**

- Check that the disconnect door fastener is tight so the disconnect switch does not open and close. If the fastener is loose, or if you hear the switch open and close while

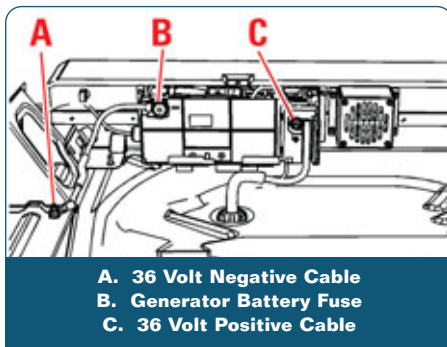
Disconnect and inspect all of the connection points, following the SI procedures, called out in the following illustrations for signs of arcing, corrosion, etc.

**A. 36 Volt Negative Cable  
B. Generator Battery Fuse  
C. 36 Volt Positive Cable**

clean all ring-terminal connection points with a wire brush.

- Apply a light coat of dielectric grease to all of the disassembled ring-terminal connection points above and to the terminals of the SGCM connectors. Refer to Bulletin #09-06-03-004 for the grease part number.
- Follow SI procedures to reassemble. It is very important to use the SI torque specifications when reassembling the ring-terminal connections.
- Reconnect the hybrid battery and reinstall the battery cover, making sure it clicks — indicating it contacts the disconnect switch. Re-evaluate the condition.

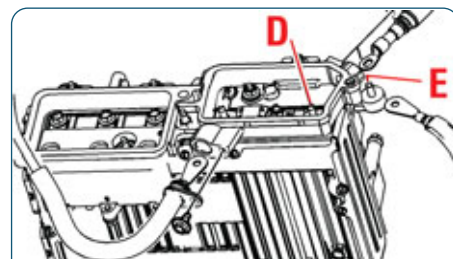
- 36 volt negative cable
- Generator battery fuse
- 36 volt positive cable
- 36 volt positive cable at generator control module
- Ground strap at generator control module and chassis connection generator control module connectors
- If any sign of arcing or corrosion is noticed on a ring-terminal, replace the related cable. If no sign of arcing is noted,

**D. 36 Volt Positive Cable at Generator Control Module  
E. Ground Strap at Generator Control Module and Chassis Connection Generator Control Module Connectors.**

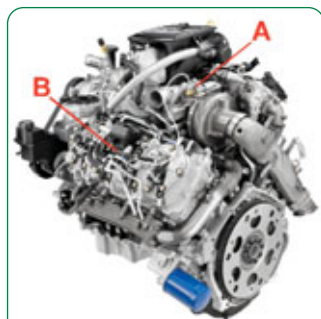
On some 2010-2011 Express, Silverado, Savana and Sierra models equipped with the Duramax diesel (RPO LHG, LML), an intermittent turbocharger Vane Position Sensor (VPS) DTC may set. To address this condition, an updated VPS

**A. Vane Position Sensor  
B. Electrical connector/module**

Complete the appropriate Service Information (SI) diagnostic procedures for any set DTCs. If DTC P2564 or P2565 is stored along with an intermittent Service Engine Soon light, also inspect the VPS serial number located on the electrical connector/module.

An updated VPS will have a serial number of -0011 or higher. If the VPS has a serial number ending in -0010, the sensor will need to be replaced.

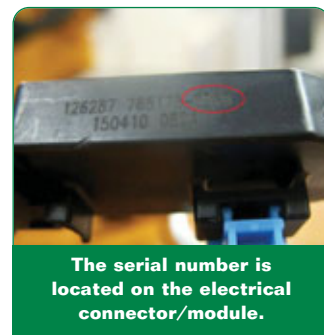
**The serial number is located on the electrical connector/module.**

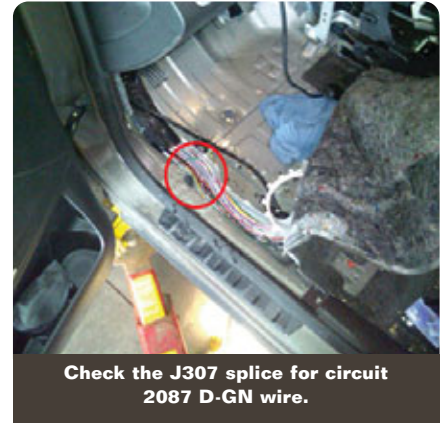
If a condition is not identified after following the Service Information diagnostics for the set DTCs, check the J307 splice for circuit 2087 (D-GN wire) for corrosion or partially broken wire strands at the splice crimp. Upon inspection the wire may easily break off when moving the harness. Complete the wire repair and clear the DTCs.

Check the J307 splice for circuit 2087 D-GN wire.

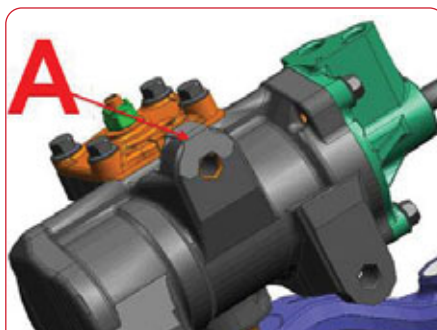
A shim (A) is used on early production steering gear box mounting locations.

When replacing a steering gear box, determine if a shim will be needed on the replacement part. If a shim is needed, use part number 22744260 and install it at the upper gear box mounting location.

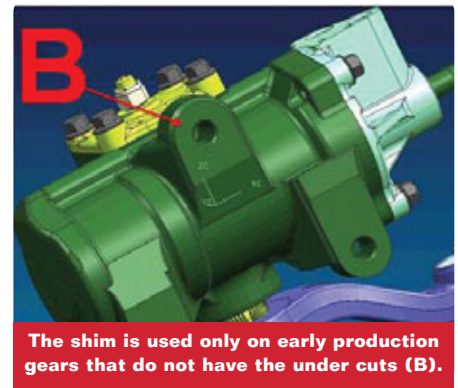
The shim is used only on early production gears that do not have the under cuts. Later production gears had under cuts made to their mounting locations and the shim is not needed.

The shim is used only on early production gears that do not have the under cuts (B).

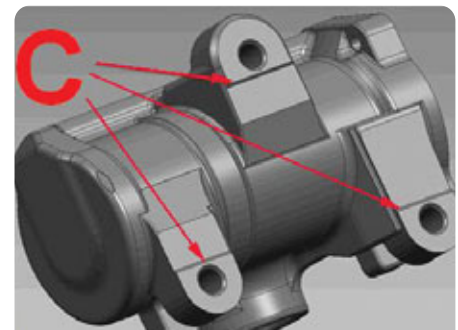
Later production gears had under cuts made to their mounting locations (C).

All production vehicles should have either the shimmed or the undercut mounting tab. If the steering gear is replaced in service, it is important to use the shim only when required.
