2012 Duramax Diesel Exhaust Fluid System Operation

2012 Duramax Diesel Exhaust Fluid System Operation	1
GM/ASE Master Automobile Technician of the Year	2
DTC P2610 Set in Duramax Diesels	3
Rear Camera Guideline Operation	3
Navigation Map SD Card	3
Repair or Replace Carbon Fiber Parts	4
Single Cylinder Valve Component Diagnostics	5
No Charge Condition	6
Electronic Power Steering Programming and Setup Information	6
Rattle Noises from Door Glass, Parking Brake Cable	6
Power Window Reversal during Express-up Operation	7
Sonic DTC P2096	7
Rear Speaker Buzz Noise	7
Sunroof Track Timing/Synchronization Procedure	7
Car Issues – Fix It Right the First Time	8
Truck Issues – Fix It Right the First Time	9
Service Know-How	9

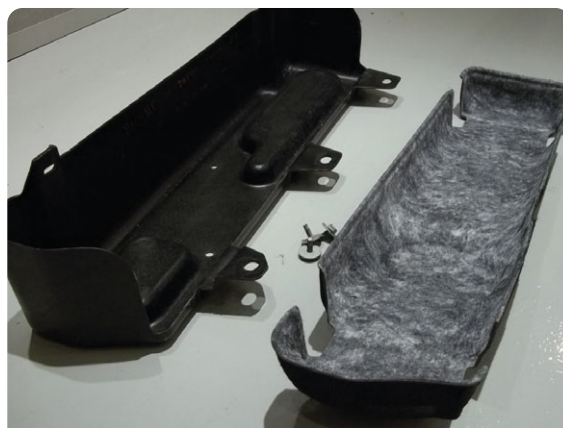
DEF tank shield and insulator

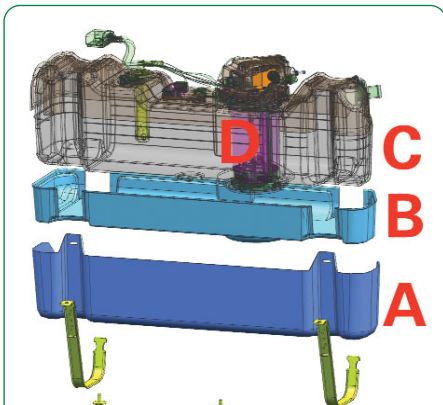
2012 model:

- A. DEF tank shield;
- B. DEF tank shield insulator;
- C. DEF tank;
- D. Reservoir assembly with updated level sensor and heater spacer

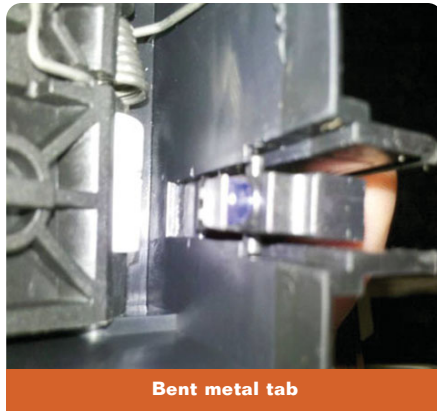
The charge port door ajar open/closed switch parameter can be seen in the Hybrid Powertrain Control Module 2 under Charge Port Door. If the charge port door reads closed when the charge port door is actually open, the vehicle will not charge and DTC P0D58 will set.

If the charge port door is always reading closed, remove the charge port assembly and inspect the charge port door open switch. If the metal tab is distorted and constantly depressing the switch, replace the charge port housing assembly.

Bent metal tab

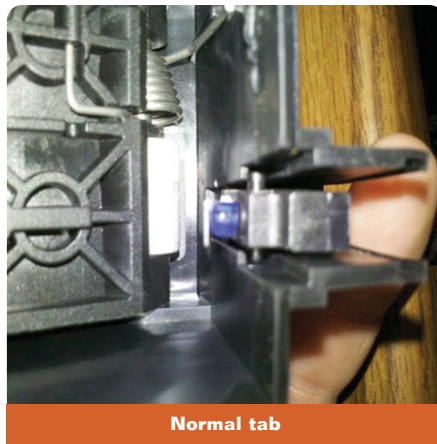
Normal tab
