A Monthly Publication for GM Dealership Service Professionals

GM TECH *Link*

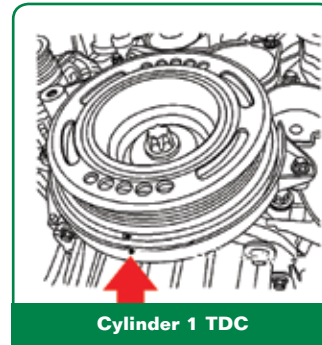
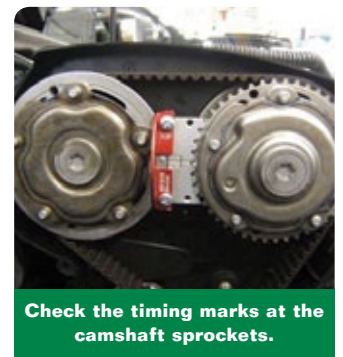
Some 2011-2012 Cruze and 2012 Sonic models equipped with the 1.8L 4-cylinder engine (RPO LUW) may have an illuminated Service Engine Soon light along with DTC P0016 (Crankshaft Position – Intake Camshaft Position Not Plausible) set. This condition may be seen most often on vehicles with low miles, generally below 300 miles (500 km).

If DTC P0016 is set and normal diagnosis does not lead to a cause, the condition may be the result of the engine being out of time.

1. Check for the camshaft position actuator to be unlocked by placing a wrench on the cam lug and for the cam to move freely from the actuator.

2. Check for proper timing of the cam actuator sprockets and the camshafts. The engine should be at cylinder 1 TDC.
3. If the marks on the cam sprockets are aligned as outlined in the appropriate Service Information, check to see if the EN-6628-A camshaft locking tool fits into the slots in the backs of the cams. If the locking tool will not fit, loosen the actuator sprockets and align the cams and sprockets. Torque the bolts.

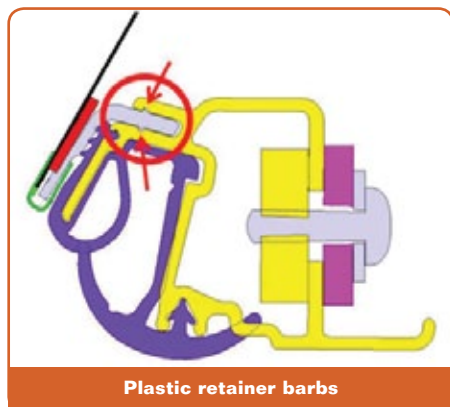
After completing a folding top repair on the Camaro convertible, check that the folding top plastic retainer strip is secure at the rear side rails. The sides of the folding top may become loose if the retainer strip is not fully seated into the rail or if the side tension cable is improperly positioned. This will result in a wind noise condition from the rear quarter glass area.

The plastic retainer has a barb on each side that will fit into a recessed portion of the rail channel. The bars could create enough resistance to make it difficult to determine if the retainer is fully seated

To ensure that the plastic retainer strip is fully seated into the rear rail:

1. Position the top in a mid-cycle position to relax the top fabric.
2. Prior to inserting the retainer into the rail channel, note the angle and orientation of the channel to make sure the retainer is inserted straight into the channel.
3. Position the side tension cable properly. There is a slit between the shorter, upper plastic retainer and the longer, lower retainer. The cable should pass through this slit in the plastic retainer.

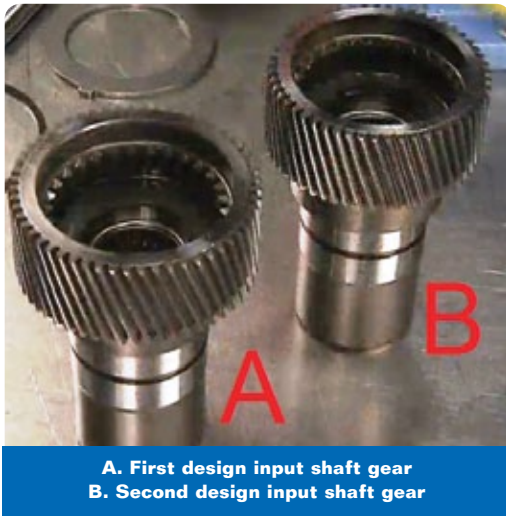
A. First design input shaft gear
B. Second design input shaft gear

The first design input shaft gear has 56 teeth and an outside diameter of 91.4 mm (3.6 inches). The second design input shaft

gear has 53 teeth and an outside diameter of 87.5 mm (3.45 inches).

The first design parts will continue to be available. Make sure that the correct parts are ordered when servicing one of these transfer cases. A 2012 vehicle could have either design, while a 2011 or earlier vehicle will usually have a first design transfer case. However, if the vehicle has had the transfer case replaced with a newer rebuilt assembly, the new assembly could contain second design components.

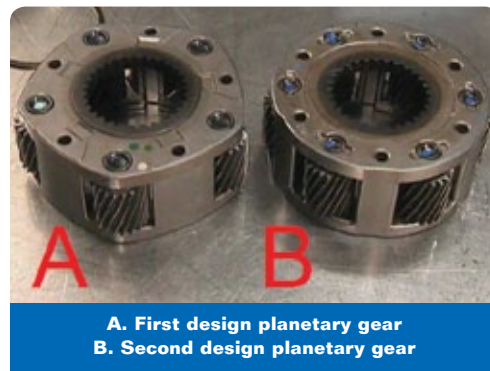
The first design planetary gear has 30 teeth and an inside diameter of 61.35 millimeters (2.4 inches). The second design has 29 teeth and an inside diameter of 60.2 millimeters (2.37 inches).

A. First design planetary gear
B. Second design planetary gear

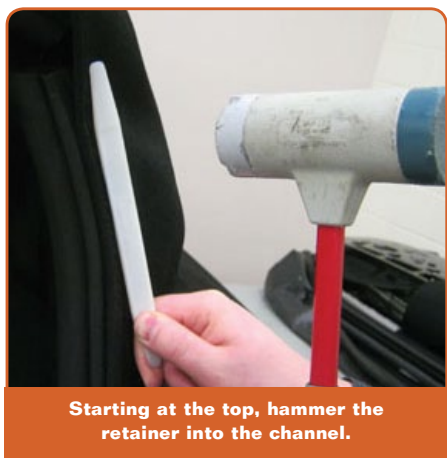
Starting at the top, hammer the retainer into the channel.

Use several strikes spaced evenly and closely together while slowly moving down to ensure the entire length of the retainer is properly seated in the channel.

Do not hammer on the seam. This will damage the plastic retainer and/or the rail. Be sure to swing the hammer in the same angle and orientation as the rear side

rail channel to ease installation and avoid damaging the plastic retainer. While some force is required, do not use excessive force when hammering.

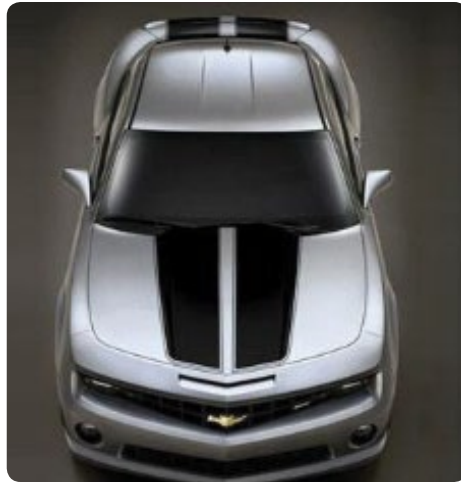
The low-gloss stripes on 2010-2012 Camaros equipped with the low-gloss GM Stripe Package may have a cloudy or hazy appearance if polish or wax is applied onto the surface of the stripes. This condition may seem to disappear when the stripes are wet and then reappear as the stripes dry. The cloudy appearance is much more likely to be noticed on darker colored stripes. It does not occur on high-gloss stripes.

If polish or wax was applied to the low-gloss stripes, the polish/wax product will have to be removed in order to restore the original appearance of the stripes. Removing the polish/wax from the stripes also will remove the wax from any other surface it contacts. The vehicle will have to be waxed again without applying wax to the stripe surfaces.

To avoid damaging the stripe material, wax removal should be done using Dawn® dishwashing liquid soap. Place a couple drops of the dishwashing liquid soap in a bucket of water, and then use a sponge and the soap solution to wash the stripes. Thoroughly wash the stripes to eliminate the wax from the small "crevices" of the matte surface.
