## Silverado and Sierra HD Trucks

# HD Trucks – continued from page 1

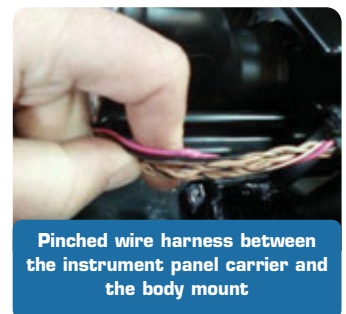
Some 2009-2010 Cobalt models equipped with the configurable Driver Information Center (DIC), RPO UAF, may have several instrument cluster warning lights illuminated as well as intermittent gauge operation. DTCs P0575, U0140, U0121, U0073 and P0703 may be stored.

These conditions may be caused by a pinched wire harness between the instrument panel carrier and the body mount.

**Pinched wire harness between the instrument panel carrier and the body mount**

Remove the instrument cluster and the instrument panel cover to gain access to the DIC harness. Inspect the harness 14 inches from the display at the instrument panel carrier mount on the left side of the instrument panel for pinched wiring and repair as necessary.
