240-Volt Charging Stations Required for Volt Dealerships

Contents

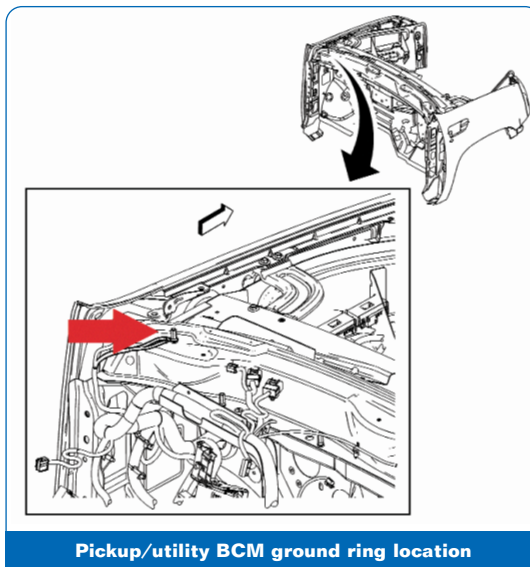
When the BCM is powered up (key in the Accessory or Run position) with the ground ring terminal removed or loose, the BCM will attempt to find a different ground path to the vehicle. This different ground path attempt may cause internal damage to the BCM.

Pickup/utility BCM ground ring location

TIP: Remove the negative battery cable if working on one of these components.

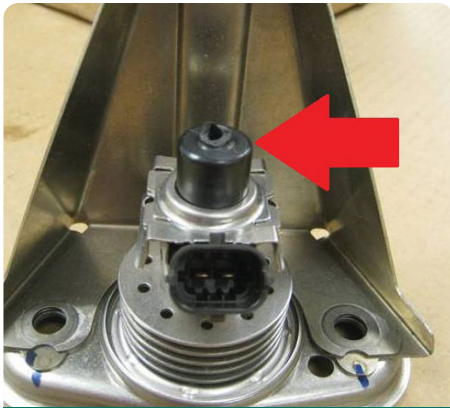
When servicing the DEF tank and DEF injector, do not overstress the DEF injector's plastic inlet nipple. Make sure the emission reduction fluid exhaust supply pipe retains slack. The nipple can fracture if overstressed.

Do not overstress the DEF injector's plastic inlet nipple.

When removing the DEF supply pipe from the DEF injector, it may be necessary to flush the connector with water to ease release of the supply pipe from the injector nipple.

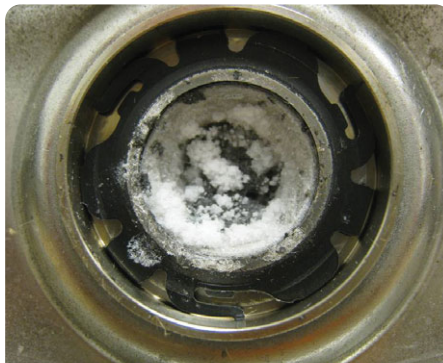
Crystalline urea deposits over the DEF injector's exit nozzle

DEF (urea) is a clear solution of approximately 32% ammonia and 68% water. When the water evaporates from the fluid, white crystalline deposits (some deposits may appear darker depending on soot incorporation) of urea remain. Since this fluid travels through the DEF injector, it is common for these deposits to form at the exit nozzle of the injector and, in some cases, inside the injector.

The presence of deposits over the DEF injector's exit nozzle alone shouldn't prompt an injector replacement. Rather, it is very important that the DEF Quantity Test — refer to the Emission Reduction Fluid Injector Quantity Test in the Service

If these deposits interfere with DEF injection, perform the quantity test a few times to allow for the DEF crystals to dissolve.

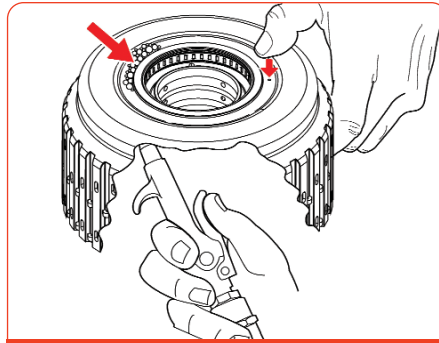
A cracked 1-2-3-4/3-5-R clutch housing may cause any of the following conditions:

Apply a soap compound and, using compressed air, inspect the weld area for bubbles.

Inspect the 1-2-3-4/3-5-R clutch housing for a possible cracked weld by applying soap compound to the weld area of the housing. Hold your thumb over the air bleed passage and spray compressed air into the piston housing. Inspect the weld area for bubbles. If bubbles are detected, a new housing is required.

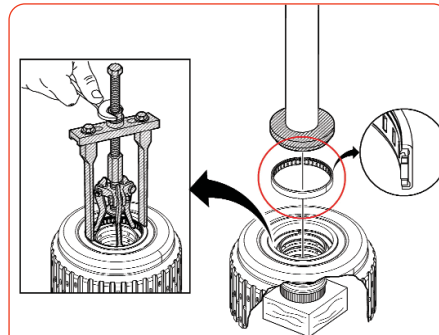
Be sure to install the 1-2-3-4/3-5-R bearing if a new clutch housing is needed.

TIP: If a new 1-2-3-4/3-5-R clutch housing is needed, be sure to install the 1-2-3-4/3-5-R bearing. If this bearing is not installed, harsh shifts will occur.
