All-Wheel-Drive Rear Differential Clutch

Techline News

All-Wheel-Drive Rear Differential Clutch	1
End of Support for Windows XP	1
Duramax Diesel Glow Plug Replacement	2
GM Goodwrench Technical Assistance Quality Survey	3
No Communication with High Speed LAN Modules	3
2011 Model Year OnStar No Connection Issues	3
2011 Cruze Passenger Presence System	4
Crankshaft Position Sensor Reluctor	5
Electronic Brake Control Module Communication	5
Intermittent Low Power after Turbo Upgrade Kit Installation	5
High Strength Steel Drill Bits	6
Engine Misfires	6
Two-Mode Hybrid Internal Transmission Wiring Harness Repairs	6
Tail Pipe Depressions	7
Two-Mode Hybrid Pickups Cargo Box Noise	7
Radio Display Fogging	7
Fix It Right the First Time	8
Service Know-How	8

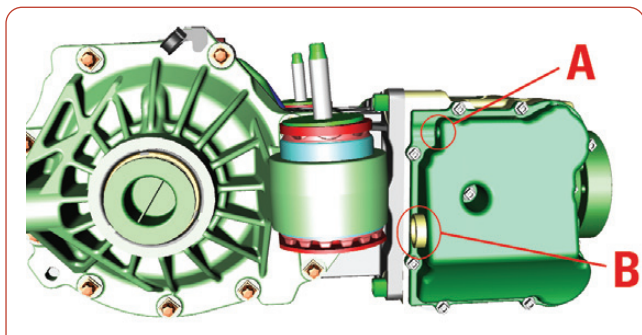
Add 350 ml of differential clutch fluid through the vent opening (A). DO NOT attempt to fill through the cover plug (B).

When filling the differential clutch housing after repairs, the fluid must be able to flow over the top of the internal wall of the pump cavity, making it imperative that the fluid is filled through the vent opening with the cover plug installed. The bottom of the cover plug opening and the internal wall are at the same level. If the cover plug is not installed, the fluid will run out of that opening before it can flow over the wall into the pump cavity.

The differential clutch must be filled through the vent fitting opening in the differential clutch cover with 350 ml (12 oz.) of differential clutch fluid, part number 88863349 (in Canada, 88863350). Fluid for the differential clutch and the rear axle are different. Fluids must not be mixed. DO NOT fill the differential clutch through the differential clutch cover plug.

Filling the clutch housing through the vent fitting opening using a syringe with a hose is recommended.

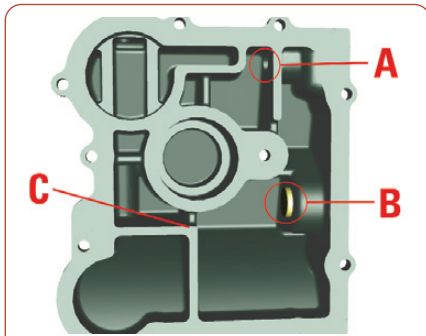
Internal view of clutch housing:
A. Vent opening B. Cover plug
C. Internal wall of pump cavity

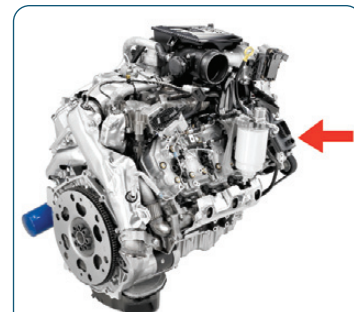
TIP: Do not replace the Glow Plug Control Module (GPCM) because the DTCs do not clear after replacing a glow plug. A glow cycle is necessary to allow the GPCM to reset the glow plug resistance calculation, which will clear the DTC. The GPCM will not power the glow plugs if the engine coolant has an elevated temperature (greater than 50° C).

DO NOT replace the Glow Plug Control Module because the DTCs do not clear after replacing a glow plug.

1. Perform the necessary repairs
2. Connect a scan tool
3. Turn on ignition 0 and ignition 1
4. Command glow via device control for 1-2 seconds
5. Clear DTCs
6. Disconnect the scan tool
7. Turn off ignition 0 and ignition 1 for 30 seconds
8. Start the vehicle and verify DTCs are not present

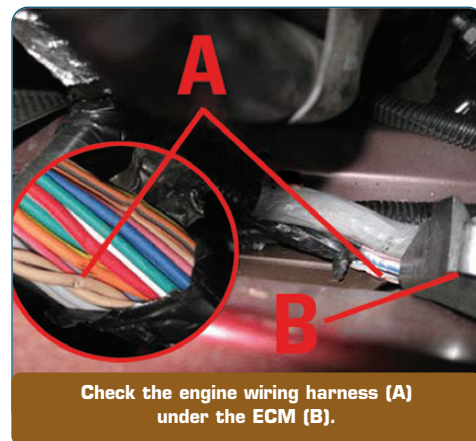
Communication to the affected control modules may be random and could change during inspection of the vehicle. Any of these conditions could be caused by a short to ground on either of the two High Speed LAN circuits 2500 and/or 2501.

Inspect the engine wiring harness under the Engine Control Module (ECM) for possible chafing on the inner fender panel.

Repair the wiring, install conduit on this area of the harness and relocate the harness away from the panel to protect it from future damage.

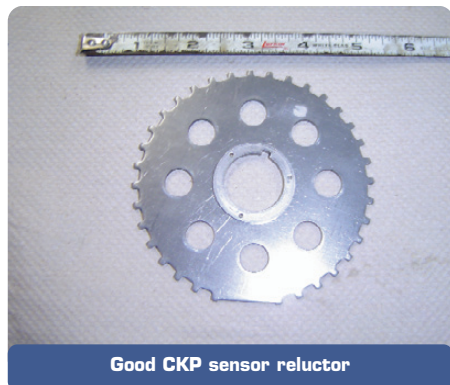
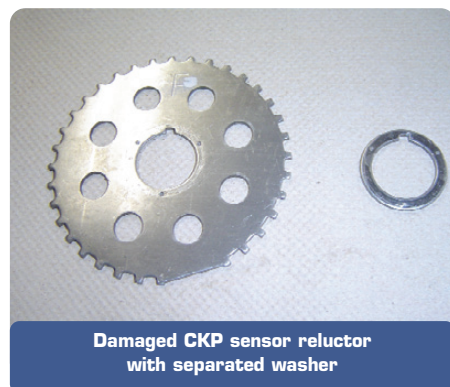
These conditions may be caused by a damaged reluctor for the CKP sensor. The reluctor is made up of two pieces: the reluctor itself with the teeth around the circumference, and a washer around the center that is welded to the reluctor.

If the welds break, the washer will separate from the reluctor, allowing the reluctor to move on the crankshaft and cause the driveability concerns. Although both the reluctor and washer are keyed, the reluctor relies on the washer to keep it stationary. Check for this condition only when the related CMP/CKP sensor DTCs are set.

A loose reluctor may be confirmed through the CKP sensor hole. If this condition is found, replace the CKP sensor reluctor.

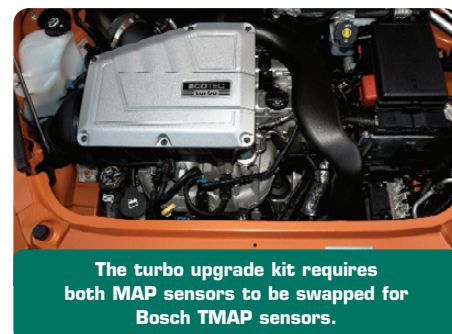
The low power condition may result from the front lower TMAP sensor (on the charge air cooler pipe) wiring rubbing and chafing against the A/C compressor or line.

A poorly sealed or improperly installed heat sealed splice sleeve on the TMAP sensor wiring also may cause this condition. Any corrosion inside the splice sleeve or at the connector may lead to an intermittent or high resistance connection and the potential for a low power condition.

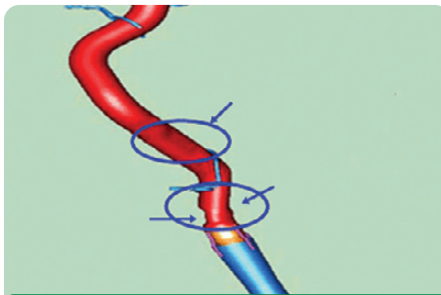
Location of depressions in the tail pipe.

be noticed. These depressions are design-intent and are purposely created to provide production tooling clearance during the assembly of the vehicle.

If the exhaust system is being inspected during diagnosis of an engine performance concern, do not replace the muffler/tail pipe assembly due to these depressions. The depressions have minimal impact on the overall exhaust system back pressure and have no effect on fuel economy or performance.

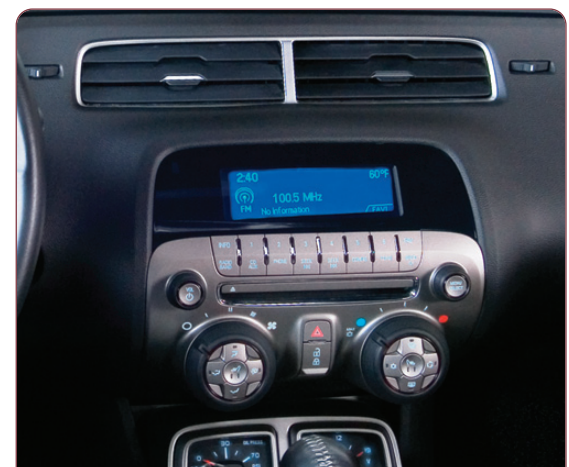
Portions of the radio display on the 2010-2011 Camaro may fog when using the air conditioning. This will typically occur when the fan speed is set to High and the center vents are pointed down toward the radio display.

This is an environmental condition induced by blowing cold air across a warm display, similar to condensation forming on a cup of ice water. This condition can be reduced or eliminated by not pointing the center instrument panel HVAC vents down toward the radio. In addition, once the vehicle interior has cooled off, it is suggested to decrease the fan speed.

Do not point the center vents down to help avoid radio display fogging.
