Techline News

Identifying Aftermarket Non-GM Calibrations

For more details, refer to bulletins 08-06-04-033 (Gasoline Engines) and 08-06-04-006A (Diesel Engines).

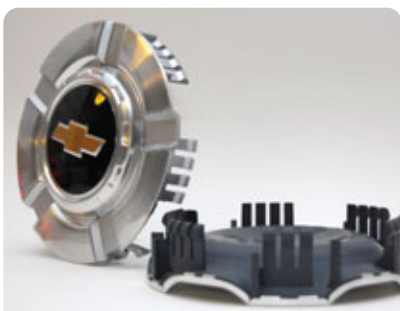
Typical center caps

The owner of a 2008-09 fullsize pickup or utility equipped with aluminum factory wheels may experience loose, missing, or noisy center caps.

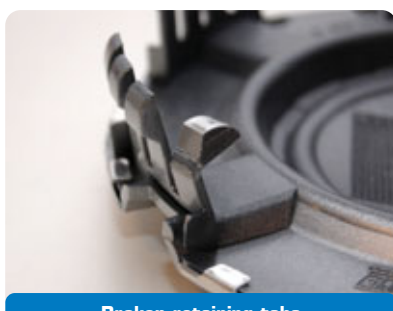
Broken retaining tabs

This may be due to an improperly installed center cap. Check for proper installation of the center cap. It is possible to install the center cap in several ways, but there is only one correct way to achieve a tight fit. Incorrect installation may result in broken retaining tabs.

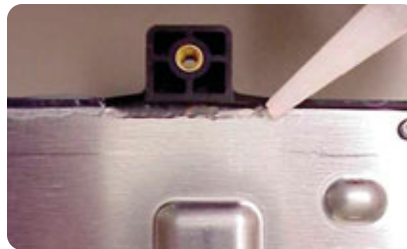
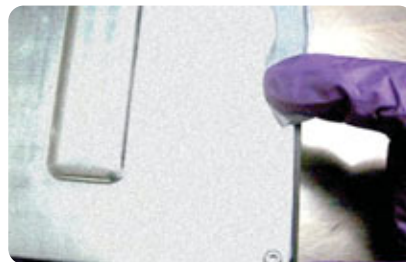
1. Intermittent crank no start condition
2. Extended crank
3. Vehicle stall condition
4. One or all of the following codes:
 - P069E, P0230 or U0109 set in the PCM
 - P0606 set in the Fuel Pump Control Module (FPCM)

1. Clean the backside surface by wiping or brushing to remove all dirt, grease, water, etc. Surface must be clean and dry.
2. Use GM approved RTV sealant p/n 12378521. (Canada p/n: 88901148).

3. Apply sealant to the joint between the aluminum back plate and the plastic housing.
4. Insure that the sealant fills the gap in the joint. Work the sealant into the joint using an index finger. Leave at least a 4mm wide bead on the surface.

5. Allow the sealant to cure at room temperature until it is firm and rubber like. This will usually take a full 24 hours to cure.
6. Install FPCM on vehicle.
