Techline News

Contents	
2010 GMC Terrain	1
Vibe PCM Calibrations Available via TIS2Web	1
Outside Air Temperature Sensor and Display	3
2010 Corvette Grand Sport	4
Loss of Oil Pressure	4
New Battery Low Start Vehicle	
Message on DIC	4
Park Assist Off Message	5
Exhaust Hanger Thump	5
Band Clamp Replacement	5
Automatic Transmission Range	
Select Lever Nut	5
Transmission to Transfer Case	
Adapter Fluid Leak	6
Power Liftgate Disable Switch	6
Environmental Performance Label	6
Radio Display Fogs when Using	
Air Conditioning	7
Poor Air Conditioning Performance	7
Engine Runs Rough, Warning	
Lights Illuminated	7
Trunk Latch	7
Fix It Right the First Time	8
Know How Broadcasts	8

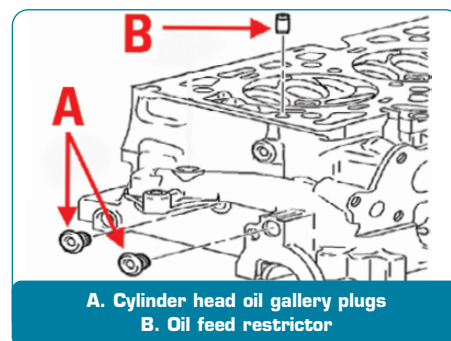
A loss of oil pressure may result in noise coming from the cylinder head. This may be caused by debris clogging the oil feed restrictor in the cylinder head passage. The oil feed hole has a small ID and may clog if excessive RTV or similar gasket or sealer has dislodged and become stuck in this passage.

This restrictor is located in the oil feed passage to the cylinder head and cannot

be inspected or cleaned without cylinder head removal.

Use a mechanical oil pressure gauge to compare the oil pressure in the block with the oil pressure in the cylinder head. The block can be checked by removing the oil pressure sender or another engine block oil gallery plug. The oil pressure to the cylinder head can be checked by removing one of the oil gallery plugs in the cylinder head.

TIP: The restrictor is not available separately from the cylinder head.

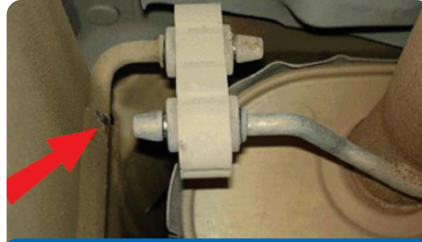
Some owners of a 2007-09 Silverado or Sierra 1500 model may comment of a thump, rattle or knock noise when turning left or when driving over bumps. This concern could be caused by the front exhaust hanger contacting the frame hanger.

Exhaust hanger contacting the frame hanger.

If contact is identified, grind the end of the exhaust hanger to 4 mm +/-2mm to provided additional clearance.

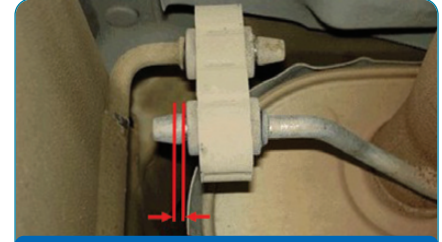
Modify the exhaust hanger to provide additional clearance

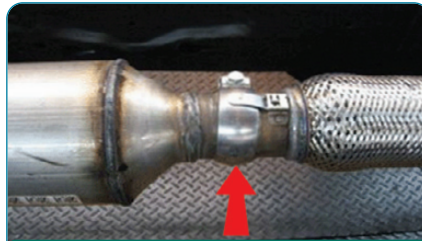
An exhaust leak or noise on full-size trucks may be caused by an unseated pipe-to-pipe mid-joint connection.

Check the mid-joint connection for an exhaust leak

A gap under the clamp edge is evidence the clamp was damaged (stretched) when installed and the clamp should be replaced.

To correct this condition, replace the band clamp and push the pipes together while tightening the clamp bolt. The pipe flares must be seated while tightening the clamp.

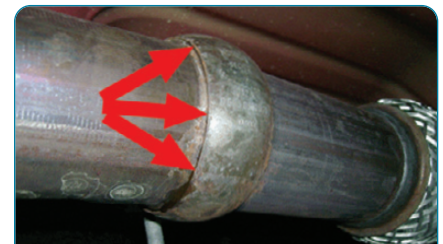
Use a new band clamp. Make sure the clamp edges are seated on the pipe.

IMPORTANT: Anytime the band clamp is removed, it should be replaced with a new clamp. It may not maintain the proper clamp load when reused.

After the band clamp is installed, it does not need to be perpendicular to the pipe. It is acceptable to have a pipe-to-pipe or clamp angle. Confirm that the clamp edges (both sides and all the way around the clamp) are seated on the pipe.

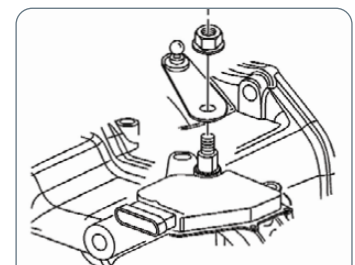
When performing repairs on all automatic transmissions, it is important to hold the transmission range select lever while removing or installing the lever retaining nut. Failure to hold the lever may cause damage to the transmission's internal park system components, which could allow the vehicle to roll when placed in the Park position.

Hold the transmission range select lever while removing or installing the lever retaining nut.

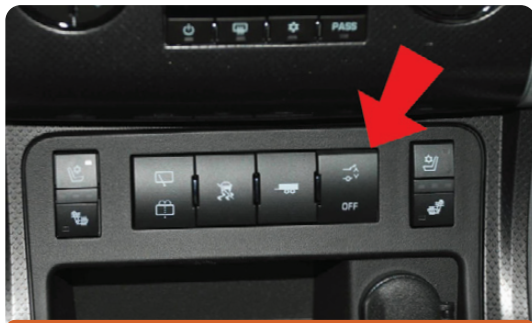
The power liftgate disable switch in the Off position.

If the driver of a 2007-10 Acadia, 2007-09 OUTLOOK, 2008-10 Enclave, or 2009-10 Traverse mentions that the power liftgate does not work, check the position of the power liftgate disable switch.

Before a repair order is written or any repairs are made, make sure that the power liftgate disable switch, located on the center of the instrument panel below the climate controls, is not switched to the Off position. In the Off position, the power function will not operate and the liftgate can only be opened or closed manually.
