GM TECH <i>Link</i>	
Contents	
Installing the Tech2Win Application	1
New Service Information Search TECHAssist	1
Electric Power Steering Control Module Replacement and Programming	3
Air Conditioning Compressor PAG Oil Quantity Change	3
Duramax Diesel Engine Performance	3
New Coaxial Cable Service Strategy	4
Individual Steering Column Part Availability	4
Steering Angle Sensor DTCs	5
Exhaust Rattle Noise	5
Inoperative Seat Heater	5
Instrument Cluster Backlighting	5
Refueling the Volt	6
Volt 12V Battery Charging	6
Volt Control Module Calibrations	6
Last Year for ASE Written Testing	7
Wheel Installation and Preventing Wheel Seizure	7
Service Know-How	7
Car Issues – Fix It Right the First Time	8
Truck Issues – Fix It Right the First Time	9

GM Customer Care and Aftersales

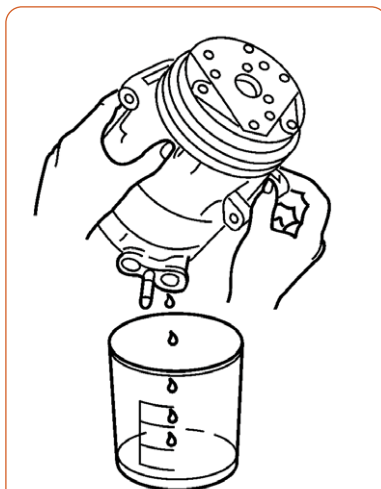
Many belt-driven air conditioning compressors in the past have contained 74 ml (2.5 oz.) of Polyalkylene Glycol (PAG) oil. To accommodate the latest vehicle A/C systems, new service A/C compressors may have a reduced quantity of PAG oil, containing only 40 ml (1.4 oz.).

Technicians should take note of the specific PAG oil quantity with every compressor replacement. The quantity must be known in order to perform the required oil balance procedure. Too much or too little PAG oil may compromise A/C system performance and compressor life.

Be sure to record the amount of oil drained from the removed compressor in order to perform the oil balance procedure before installing the service compressor.

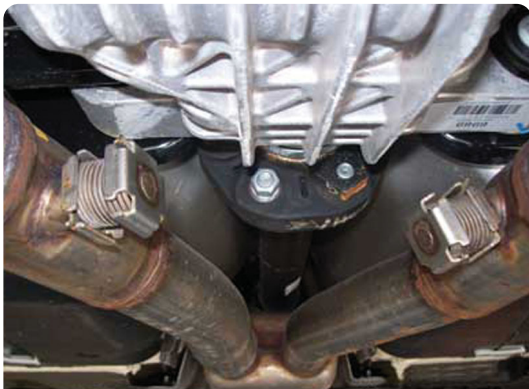
Spring-loaded valve in the exhaust system

It is characteristic of this spring-loaded valve to make some noise during engine operation or when tapping on the exhaust pipes. No parts should be replaced or repaired for this noise.

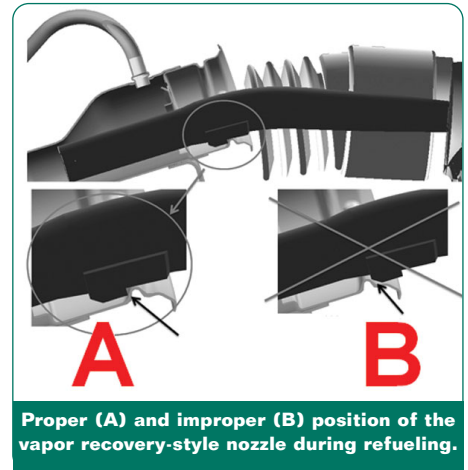
Proper (A) and improper (B) position of the vapor recovery-style nozzle during refueling.

three more pump "clicks" into the tank. Forcing excessive fuel into the tank can cause conditions with the vehicle's EVAP system.

Inform the customer to not overfill the fuel tank. After the fuel pump has shut off when refueling, do not force any more than

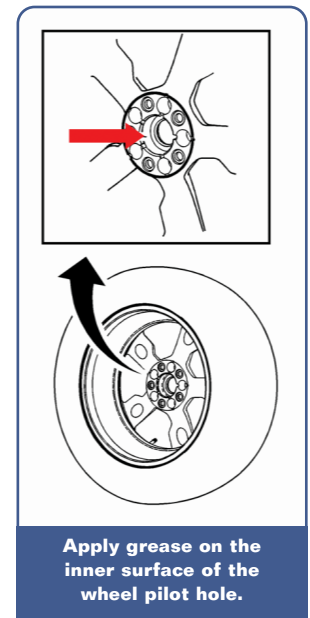
Apply grease on the inner surface of the wheel pilot hole.

Beginning with 2011 model year vehicles, as part of tire and wheel installation, GM recommends putting a light coating of grease on the inner surface of the wheel pilot hole to prevent wheel seizure to the axle or bearing hub.

If wheel removal is difficult, it's recommended to apply the grease before installing the wheel for all model year vehicles.
