## New DURAMAX Diesel Engines

## Contents

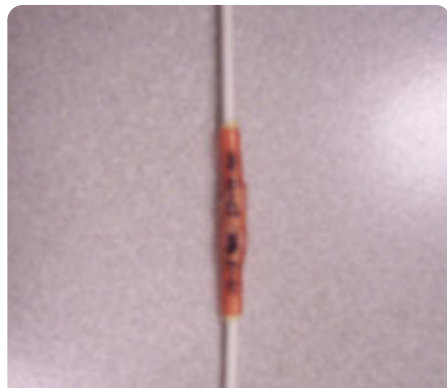
Wire harness insulation that has been damaged, chafed or broken, showing the conductive portion of the wire without having any damage to the wire itself, should be repaired.

Wire spliced and sealed with heat shrink tubing

1. Cut the wire within the damaged area
2. Cut a piece of appropriate heat shrink tubing that is one inch longer than damaged area
3. Slide the heat shrink tubing over the wire
4. Splice the cut wires together. Refer to Splicing Copper Wire Using Splice Sleeves in SI
5. Slide the heat shrink tubing over the damaged area and apply heat to seal the repaired wire

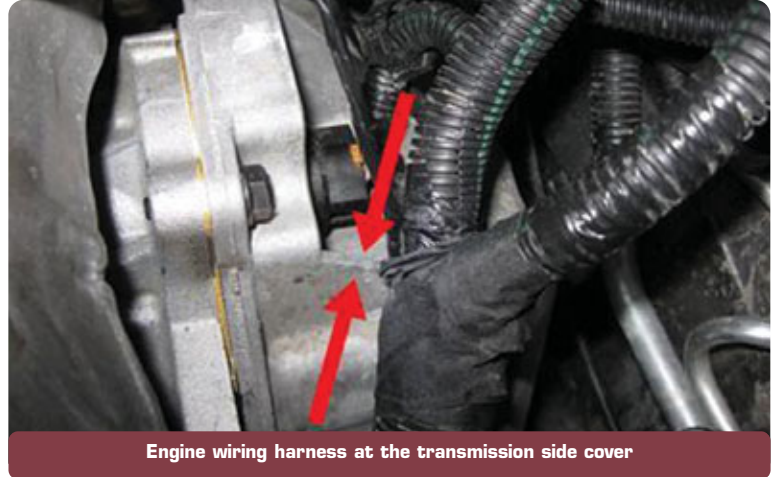
The 2009-2010 Impala may have the SES (Service Engine Soon) light illuminated and/or the vehicle may be operating under reduced engine power. The following DTCs may be set: P2120, P2122, P2123, P2125, P2127, P2128, or P2138.

Engine wiring harness at the transmission side cover

Prior to replacing the Accelerator Pedal Position (APP) sensor or the Engine Control Module (ECM), check the following:

- Check terminal tension for the APP circuits (circuits 1164, 1161, 1271, 1274, 1162, 1272) at the APP sensor, X111, and ECM using the appropriate test probe per the Service Information.
- Check for proper routing of the engine wiring harness. A common location where a chafe can occur in the engine wiring harness is at the transmission side cover. Also visually check the engine wiring harness outside of the APP circuits for any signs of chafing or other issues.
- Be aware that other engine sensors that have a 5 volt reference may share the 5 volt feed internally to the ECM. The sharing of this reference voltage could cause DTC misdiagnosis.

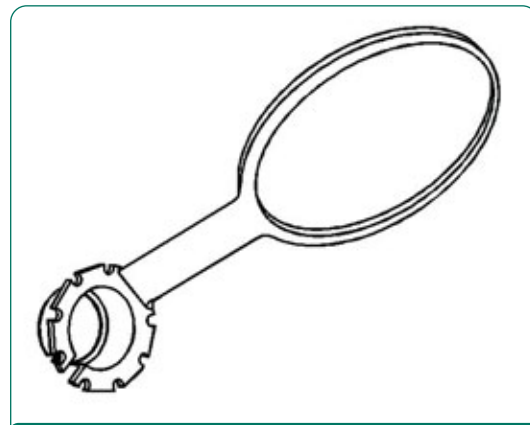
Oil seal protector tool J44394-A

If the front drive axle assembly is removed during service on any 2008 to present vehicle equipped with the GF-6 (6T30/6T40/6T45/ and 6T50) transmission or 6T70/6T75 transmission, the transmission axle oil seal should be replaced.

The transmission axle oil seal can be easily damaged by the drive axle end splines if the splines make contact with the seal during drive axle removal. This may lead to a transmission oil leak after a drive axle has been removed for service.

**TIP:** Use the oil seal protector tool (J44394-A) when the drive axle is reinstalled to prevent the new seal from being damaged.
