LED Headlamps

Techline News

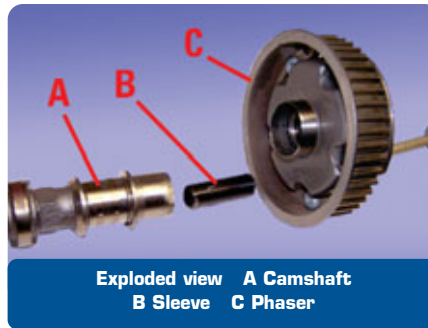
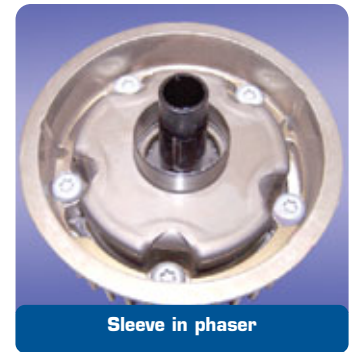
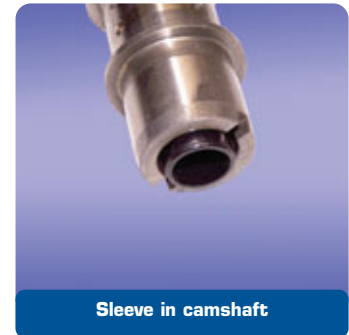
Camshaft Phaser

Typically these DTCs set after a cam phaser has been removed and replaced. If the engine timing has been verified and you have followed SI diagnostics and the code(s) returned, the following may help.

The 1.6L (RPO-LXV) engine has a unique black plastic sleeve that is inserted into the end of the cam phaser and camshaft. This sleeve directs oil to the phaser to advance or retard the cam timing. If the sleeve is missing or damaged, the ECM cannot control the phaser movement which may result in a DTC P0011, P0014, P0016 and or P0017. This sleeve may be confused with a shipping aid, as it comes with new phasers. Be careful when service work is performed to insure installation of this sleeve when reassembling the engine.

TIP: These sleeves are not shown in EPC and are available only as part of the camshaft phaser assembly at this time. Additional information will be made available when changes are made.
