DEXRON®-VI

Techline News

Non-OEM Oil Change Concerns

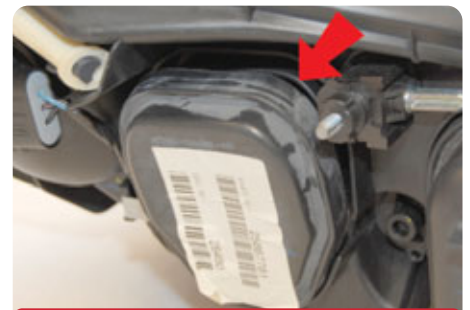
Customers may notice moisture formed inside the headlamp lens. This may be caused by the rubber headlamp bulb access covers not being installed properly. There is a separate cover for each of the four headlamp bulbs. If a cover is not properly seated, water can leak into the headlamp housing and condense on the inside of the lens.

Low beam cover loose

Be sure all four covers are present and properly seated. If a cover is missing, service replacement parts are available.

Simply press the flange of the cover fully into the locating groove.

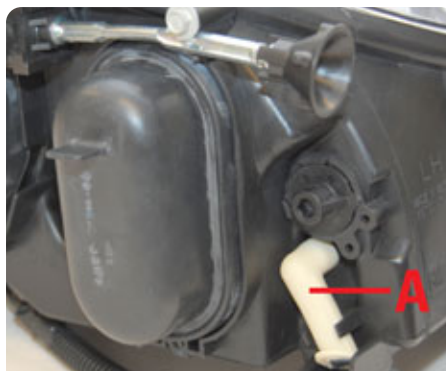
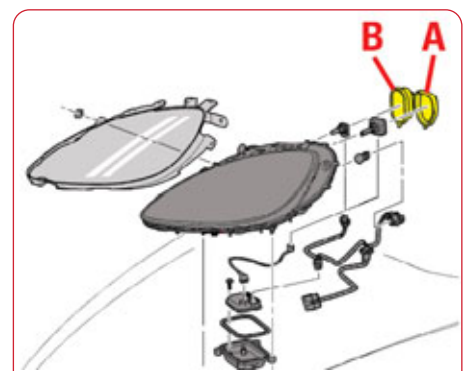
High beam cover installed
A Vent tube

A Cover, Low Beam 12335924
B Cover, High Beam 12335925

After the covers are properly installed and headlamps are turned on, moisture will evaporate and pass from the housing through the vent tube.

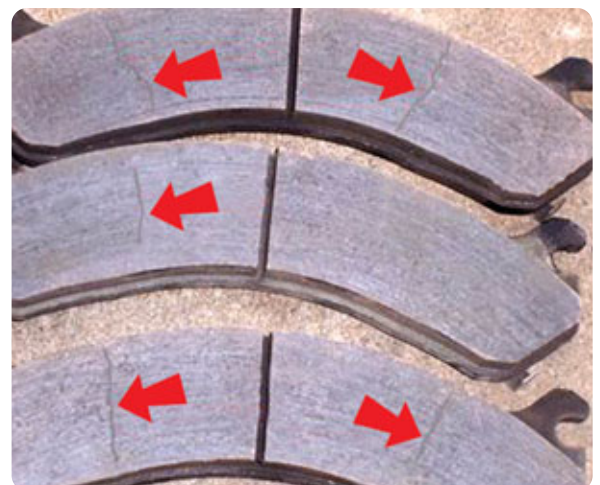
When performing a brake inspection on a 2007-09 Chevrolet Silverado 3500HD or GMC Sierra 3500HD with brake RPO JK4 or JH7, hairline cracks may be noticed in the pad friction material. Cracks in the friction material can occur after the pads have been subjected to high pad temperatures.

These hairline cracks do not affect the operation of the brake system and the pads should not be replaced if only hairline cracks are found.
