## Remote Keyless Entry Interference

### GM TECH *Link*

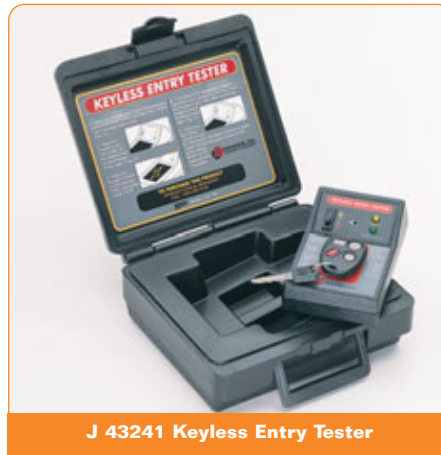
J 43241 Keyless Entry Tester

Also use the J 43241 tester to test the functionality of each button on the transmitter. The tester should sound a tone and illuminate the green LED when each transmitter button is pressed. If a button fails, replace the transmitter battery and test the transmitter again before replacing it.

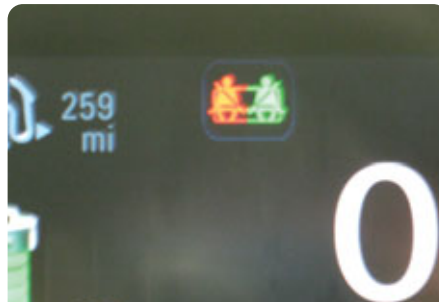
In this example, the indicator shows that the right-side seat belt is buckled and the left-side seat belt is unbuckled.

The indicator has two sections to specify which seatbelts are buckled. If a seatbelt is unbuckled, the indicator will be red, and if the seatbelt is buckled, the indicator will be green.

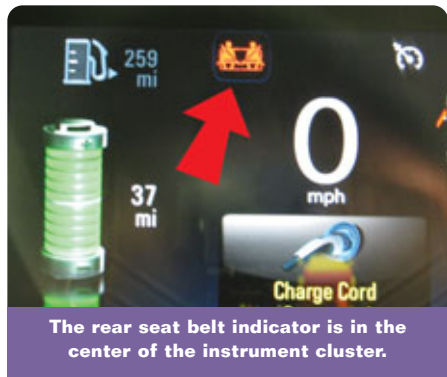
The rear seat belt indicator is in the center of the instrument cluster.

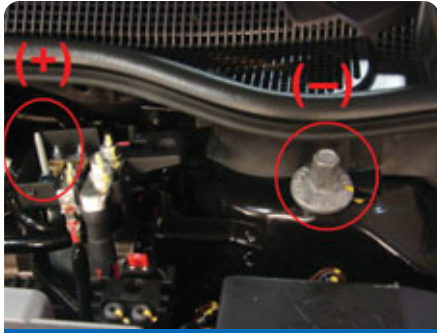
The 12-volt battery on the 2011 Volt is located below the cargo floor in the rear hatch. When attempting to jump start a dead 12V battery, use the remote 12V terminals located under the hood on the driver's side of the vehicle. The positive terminal is under an access cover. The negative terminal is marked GND. These terminals should be used for jump starting because the rear hatch is inaccessible with a dead 12V battery.

Use the remote 12V terminals under the hood when jump starting the Volt.

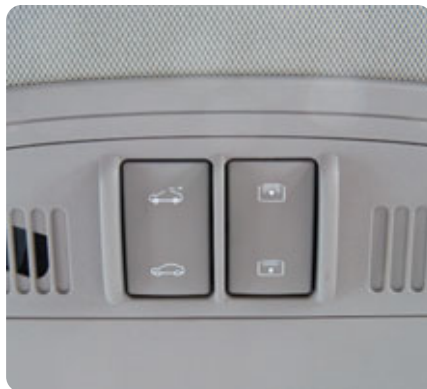
The sunroof and/or sunshade on the 2010-2011 LaCrosse may not close or may not close properly when using the express feature.

The sunroof must be learned before the sunshade can be learned. The sunshade may appear to function properly for a time if the sunroof is not learned.

To determine if the sunroof/sunshade relearn procedure should be performed, connect GDS 2 and select Module Diagnosis > Body Control Module > Data Display. Select Sunroof Data from the drop-down menu and check the lines for Sunroof and Sunshade Not Learned. If either indicates "active," proceed with the next steps.
