2012 Duramax Diesel Exhaust Fluid System Operation

2012 Duramax Diesel Exhaust Fluid System Operation	1
GM/ASE Master Automobile Technician of the Year	2
DTC P2610 Set in Duramax Diesels	3
Rear Camera Guideline Operation	3
Navigation Map SD Card	3
Repair or Replace Carbon Fiber Parts	4
Single Cylinder Valve Component Diagnostics	5
No Charge Condition	6
Electronic Power Steering Programming and Setup Information	6
Rattle Noises from Door Glass, Parking Brake Cable	6
Power Window Reversal during Express-up Operation	7
Sonic DTC P2096	7
Rear Speaker Buzz Noise	7
Sunroof Track Timing/Synchronization Procedure	7
Car Issues – Fix It Right the First Time	8
Truck Issues – Fix It Right the First Time	9
Service Know-How	9

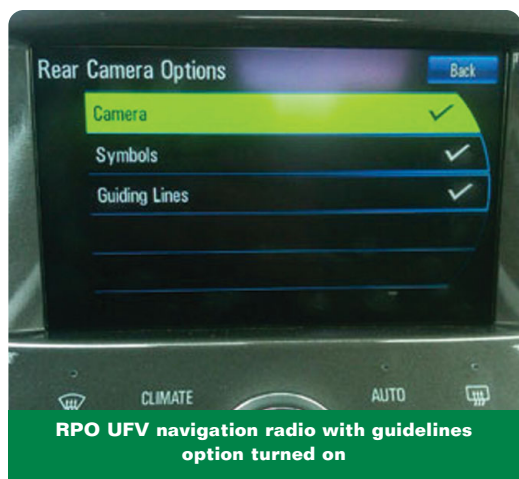
Rear Camera Guideline Operation

On the 2011-2012 Volt, the guidelines for the rear camera display are only available with navigation radio RPO UFV. No other radios will support this feature.

If the guidelines are not visible, verify the RPO of the radio. If the vehicle is equipped with RPO UFV, verify the guidelines are turned on by using the radio controls. Press the CONFIG button, and then select Display, and then Guidelines. If a check mark is present, the guidelines are turned on.

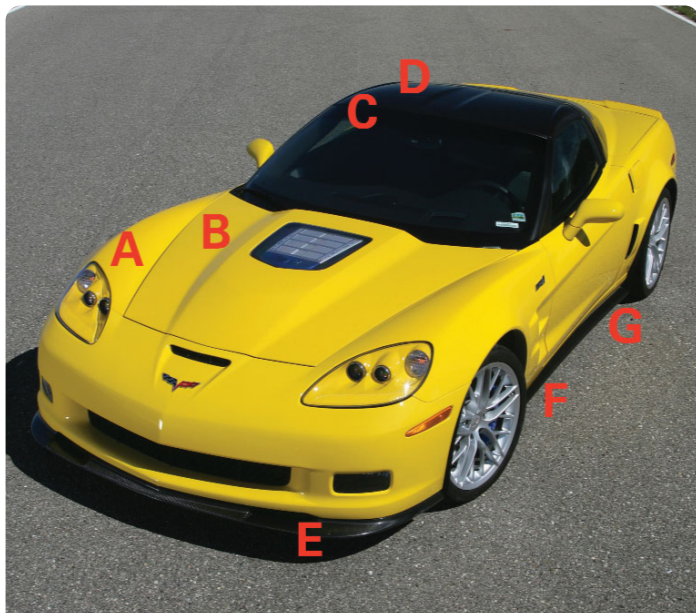
Corvette ZR1 carbon fiber components include:
A. fenders, B. hood, C. roof panel, D. roof bow,
E. splitter, F. rocker moldings, G. floor panels

All of the exterior exposed weave carbon fiber panels (ZR1 roof, roof bow, splitter and rocker moldings) have a clear coat to protect them against ultraviolet light (UV) fading and degradation. If the clear coat protection is scratched, or rubbed away, the panel beneath is no longer protected. When unprotected carbon fiber is exposed to UV rays, the color will lighten significantly and cause it to appear white or bleached.

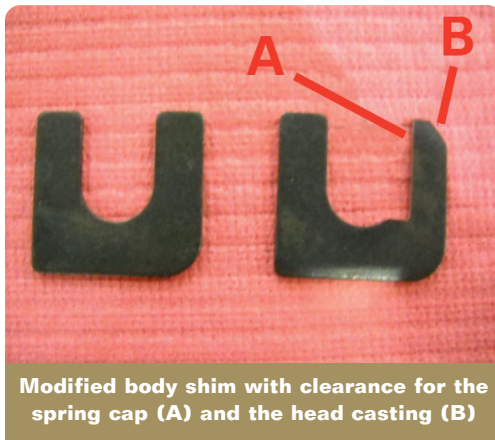
Before beginning the procedure, modify a standard body shim with a standard body file to fit around the valve cap (two shims are required because the standard Kent-Moore valve spring compressor tool doesn't compress the spring far enough). The modified body shim will have clearance for the spring cap and the head casting.

1. Remove the cam cover.
2. Place two modified body shims on the valve spring cap for the valve position to be repaired. The engine must be rotated until the cam lobe is pointing up away from the valve so there is enough clearance for the procedure.

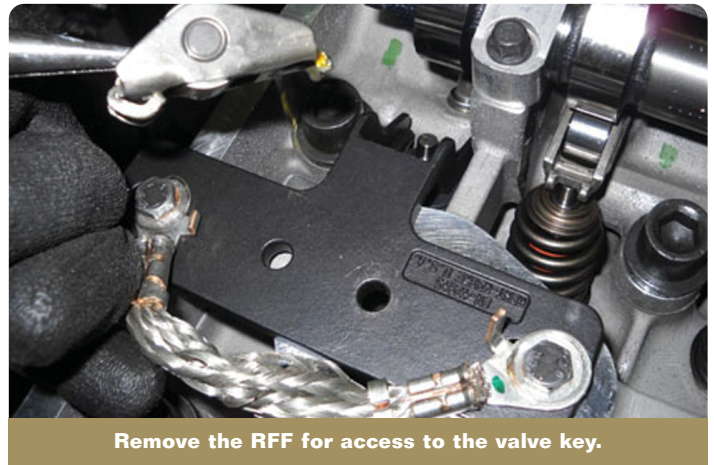
Remove the RFF for access to the valve key.

7. With the valve spring compressed, the valve stem is exposed so that the key can be removed or replaced.

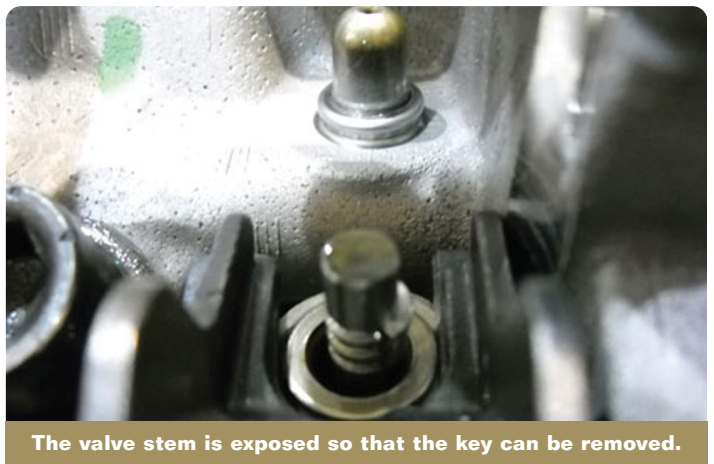
The valve stem is exposed so that the key can be removed.

8. Push the valve stem all the way down into the spring cap to seat the keys and provide enough clearance to re-install the RFF.
