A Monthly Publication for GM Dealership Service Professionals

GM TECH *Link*

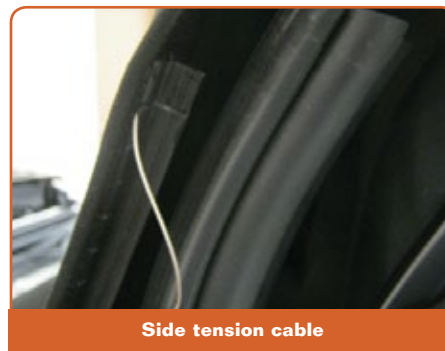
1. Position the top in a mid-cycle position to relax the top fabric.
2. Prior to inserting the retainer into the rail channel, note the angle and orientation of the channel to make sure the retainer is inserted straight into the channel.
3. Position the side tension cable properly. There is a slit between the shorter, upper plastic retainer and the longer, lower retainer. The cable should pass through this slit in the plastic retainer.

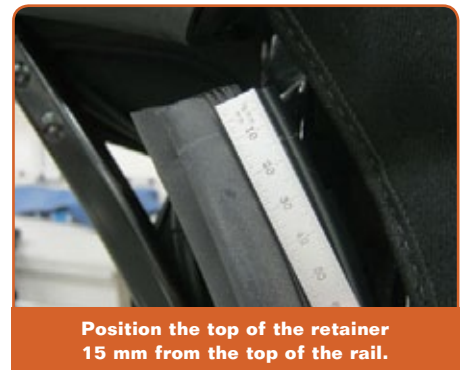
4. Insert the retainer into the rail, positioning the top of the retainer 15 mm from the top of the rail. There may be a silver mark on the rail to indicate the starting point of the retainer. If the mark is not present, make a mark 15 mm below the top of the rail.

5. Using the seam to properly position the trim stick, place the trim stick on the top cloth next to the seam and directly over the plastic retainer.
6. Starting at the top and working down, hammer the retainer into the channel.
