240-Volt Charging Stations Required for Volt Dealerships

Contents

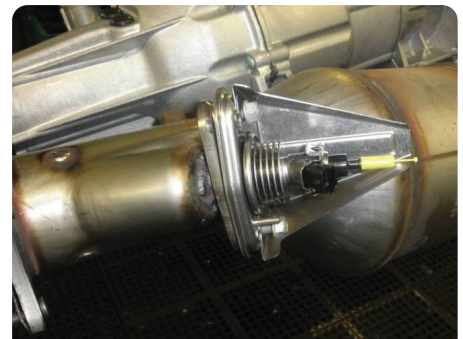
The DEF injector is mounted just downstream of the DOC canister on the DOC exhaust pipe.

TIP: To help maintain DEF injector integrity, let the vehicle idle for 10 minutes immediately after a service regeneration before turning off the engine. This allows time for the DEF injector to cool.

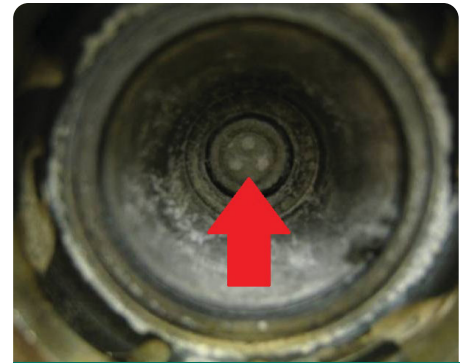
The three separate DEF injector outlet ports
