All-Wheel-Drive Rear Differential Clutch

Techline News

All-Wheel-Drive Rear Differential Clutch	1
End of Support for Windows XP	1
Duramax Diesel Glow Plug Replacement	2
GM Goodwrench Technical Assistance Quality Survey	3
No Communication with High Speed LAN Modules	3
2011 Model Year OnStar No Connection Issues	3
2011 Cruze Passenger Presence System	4
Crankshaft Position Sensor Reluctor	5
Electronic Brake Control Module Communication	5
Intermittent Low Power after Turbo Upgrade Kit Installation	5
High Strength Steel Drill Bits	6
Engine Misfires	6
Two-Mode Hybrid Internal Transmission Wiring Harness Repairs	6
Tail Pipe Depressions	7
Two-Mode Hybrid Pickups Cargo Box Noise	7
Radio Display Fogging	7
Fix It Right the First Time	8
Service Know-How	8

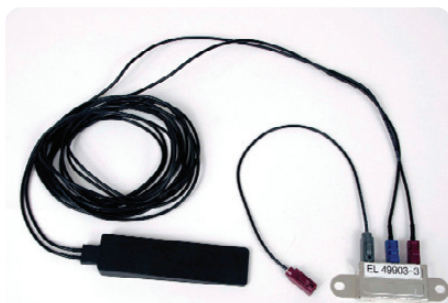
EL 49903 OnStar antenna test tool and EL 49903-3 adapter

The OnStar antenna test tool should be used for conditions where the vehicle is unable to connect to the OnStar call center. The tool will help to isolate the condition to the antenna or the module.

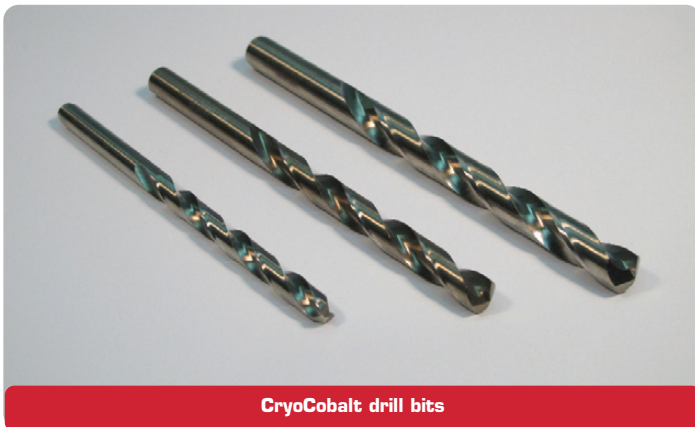
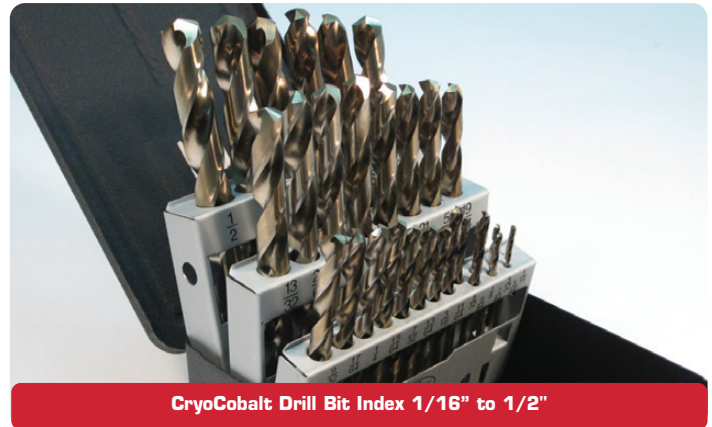
The CryoCobalt drill bits have increased microsharpness for use on hardened, high strength alloy steels along with a thicker web that withstands the higher feed pressure required for drilling

CryoCobalt: drill bits

CryoCobalt Drill Bit Index 1/16" to 1/2"

Refer to Bulletin #10-08-98-002 for part numbers and ordering information. The drill bits listed are available directly from the manufacturer with special GM pricing.
