Techline News

Identifying Aftermarket Non-GM Calibrations

For more details, refer to bulletins 08-06-04-033 (Gasoline Engines) and 08-06-04-006A (Diesel Engines).

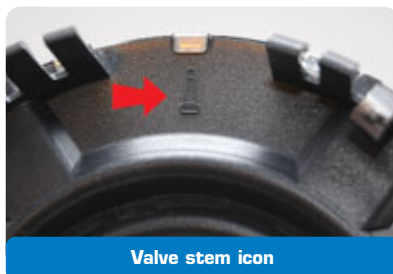
Broken retaining tabs

The owner of a 2008-09 fullsize pickup or utility equipped with aluminum factory wheels may experience loose, missing, or noisy center caps.

This may be due to an improperly installed center cap. Check for proper installation of the center cap. It is possible to install the center cap in several ways, but there is only one correct way to achieve a tight fit. Incorrect installation may result in broken retaining tabs.

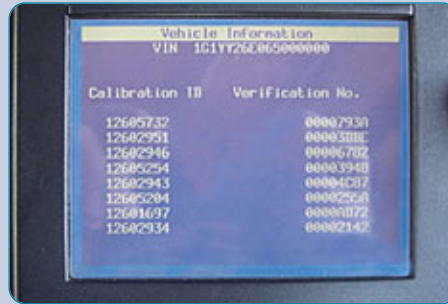
General Motors is identifying an increasing number of engine, transmission and catalytic converter part failures that are the result of non GM – aftermarket engine and transmission control calibrations being used.

When alteration to the GM released engine or transmission control calibrations occurs, it subjects powertrain and driveline components (engine, transmission, transfer case, driveshaft and rear axle) to stresses that were not tested by General Motors. It is because of these unknown stresses, and the potential to alter reliability, durability and emissions performance, that GM has adopted a policy to cancel any remaining warranty coverage to the powertrain and driveline components, whenever the presence of a non-GM/aftermarket calibration is confirmed – even if the non-GM control module calibration is subsequently removed.

Warranty coverage is based on the equipment and calibrations that were released on the vehicle at time of sale, or subsequently updated by GM. That's because GM testing and validation matches the calibration to a host of criteria that are essential to assure reliability, durability and emissions performance over the life of the warranty coverage and beyond. Stresses resulting from calibrations different than those tested and released by GM can damage or weaken components, leading to poor performance and or shortened life.

Additionally, non-GM-issued aftermarket engine control modifications often do not meet the same emissions performance standards as GM-issued calibrations. Depending on state statutes, individuals who install engine control module calibrations that put the vehicle outside the parameters of emissions certification standards may be subject to fines and/or penalties.

GM service bulletins 08-06-04-033 and 08-06-04-006 outline procedures to identify the presence of non-GM/aftermarket calibrations. GM recommends performing this check whenever a hard part failure is seen on internal engine or transmission components, or before an engine assembly or transmission assembly is being replaced under warranty. It is also recommended that the engine calibration verification procedure be performed whenever diagnostics indicate that catalytic converter replacement is indicated.

In February 2009, PQC will begin piloting a process to confirm the ECM calibration is GM-issued. Beginning in February, PQC will require a picture of the engine calibration verification screen, as outlined in the bulletin, before authorizing any V8 engine replacement (both Gas and Diesel).
