DEXRON®-VI

Techline News

Non-OEM Oil Change Concerns

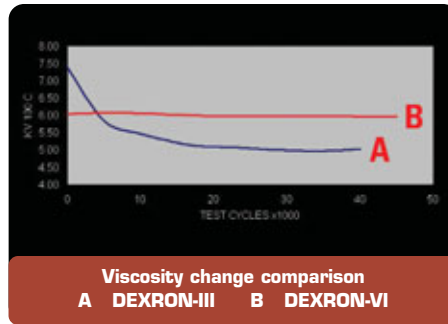
Viscosity Stability (greatly improved) – Viscosity is a description of how thick or thin a fluid is at various temperatures. In a hydraulic system, components can function sluggishly or improperly when viscosity is wrong. As determined by comparison testing,

DEXRON-VI maintains an almost constant viscosity over time, while the viscosity of DEXRON-III degrades considerably.

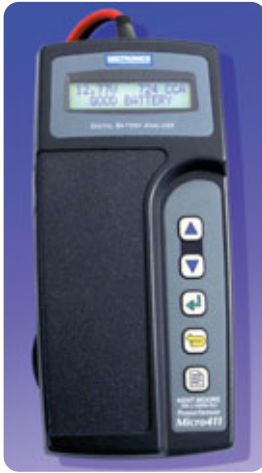
A new battery is considered "unformed" until it has been through several discharge/charge cycles. This means a new, unformed battery will not be capable of producing its optimum current and cold cranking amps (CCA). If an "unformed" battery is tested using the Midtronics J-42000 or similar Conductance Tester, the resulting CCA may be lower than indicated on the battery's rating label. This could lead to condemning an otherwise good battery.

voltmeter (DVOM) to be sure there is adequate voltage to start the vehicle. The battery should be in service for several days before performing a conductance test.

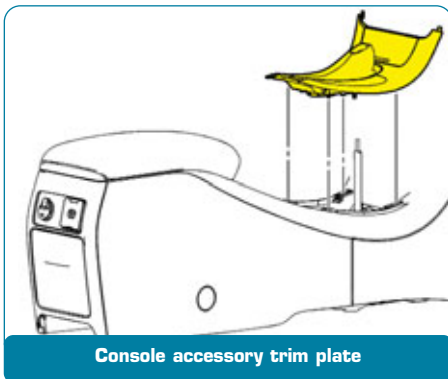
Console accessory trim plate

On the Malibu, if the IP accessory trim plate is removed incorrectly, it may be damaged. There are 2 hidden screws and 8 clips. Here are some tips.

1. Remove the shift control knob.
2. Use a flat bladed plastic trim tool to release the retaining clips on the bottom side of the front floor console accessory trim plate. Remove the trim plate. Disconnect electrical connections.

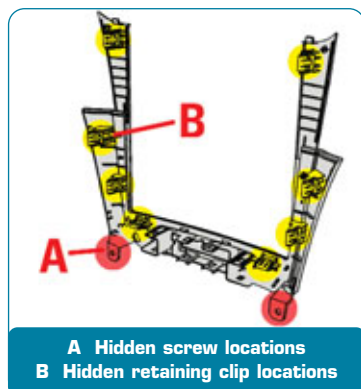
A Hidden screw locations
B Hidden retaining clip locations

3. This gives access to remove two hidden screws at the bottom of the IP accessory trim plate.
4. Use a flat bladed plastic trim tool to release the retaining clips on the back side of the IP accessory trim plate. There are three on each side of the opening, and an additional two below the opening. Disconnect electrical connections.
5. Lift the IP accessory trim plate away from the instrument panel.

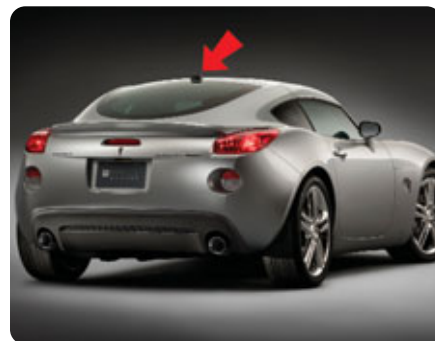
XM Antenna

All Solstice coupes will be equipped with an XM antenna, whether the vehicle actually has an XM radio or not.
