Techline News

Contents	
2010 GMC Terrain	1
Vibe PCM Calibrations Available via TIS2Web	1
Outside Air Temperature Sensor and Display	3
2010 Corvette Grand Sport	4
Loss of Oil Pressure	4
New Battery Low Start Vehicle	
Message on DIC	4
Park Assist Off Message	5
Exhaust Hanger Thump	5
Band Clamp Replacement	5
Automatic Transmission Range	
Select Lever Nut	5
Transmission to Transfer Case	
Adapter Fluid Leak	6
Power Liftgate Disable Switch	6
Environmental Performance Label	6
Radio Display Fogs when Using	
Air Conditioning	7
Poor Air Conditioning Performance	7
Engine Runs Rough, Warning	
Lights Illuminated	7
Trunk Latch	7
Fix It Right the First Time	8
Know How Broadcasts	8

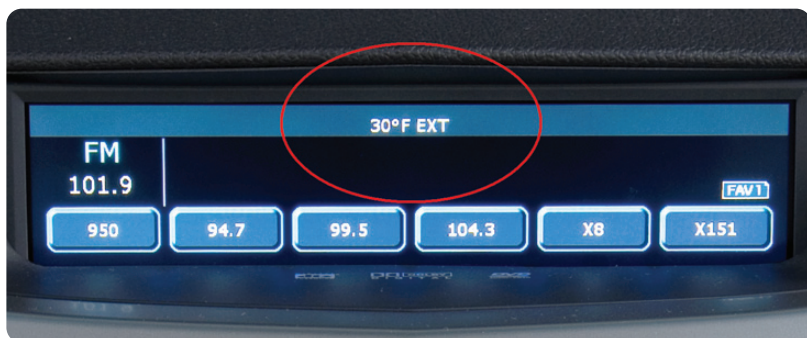
The sensor measures temperatures between -30°C and 51°C (-22°F and 123.8°F). The device is an NTC thermistor (a ceramic material that decreases in resistance with increasing temperature). The specifications of the sensor are very good; less than $\pm 1^{\circ}\text{C}$ (1.8°F) in very cold conditions and less than $\pm 0.5^{\circ}\text{C}$ (1°F) in warm to hot conditions. The sensors have a proven reliability record and almost never show issues when returned in service.

The main source of variation between actual outside temperature and the reading inside the vehicle is the variable airflow across the sensor at low vehicle speed and stopped conditions. The front end of a vehicle (at low speeds) is generally a very warm place when the vehicle is or has recently been running. This warmth would normally cause big differences between the real ambient temperature and the reading in the display. At higher speeds, when more fresh airflow is moving through the front end of the vehicle, a much more accurate indication of actual air temperature is provided.

To prevent large indicated temperature increases at low vehicle speeds, very slow mathematical averaging keeps the temperature from creeping up in stop and go traffic. When the vehicle is stopped (idling) or moving at very low speeds (less than 10mph/16kph) the sensor is ignored as it rises and the indicated display does not change (decreases in actual temperature are allowed). So in city traffic with stop-and-go conditions at lower speeds, the displayed temperature may never increase.

In service, using the vehicle display to diagnose problems with the outside air temperature sensor is not advised. The display is not updated when the vehicle is stopped, so holding or warming the sensor will not affect the vehicle display at idle. Unplugging the sensor will blank the display (even at idle) and set DTC B0158. If a sensor is then plugged back in, the display will update to the current sensor actual temperature. This has led to several misdiagnosed sensor replacements, assuming that the new sensor gives a better reading than the old sensor. Use the Tech 2 with the latest software update to diagnose concerns with the sensor reading.

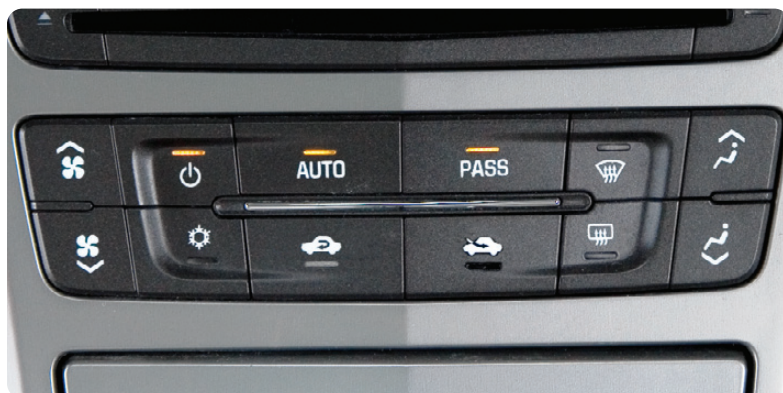
Since its launch in July 2007, the Cadillac CTS HVAC software has a provision for an instantaneous update of the outside air temperature display to the actual sensor reading. Pressing and holding the A/C (snowflake) button and the adjacent Recirculation button simultaneously for about 3 seconds will update the display to the current unfiltered sensor reading.

This can be used for diagnostics as well as by a customer who parks in an underground garage on a regular basis before heading out into warmer weather. After the display is updated, the same filters are used (at the new temperature) to help make the display accurate and stable.

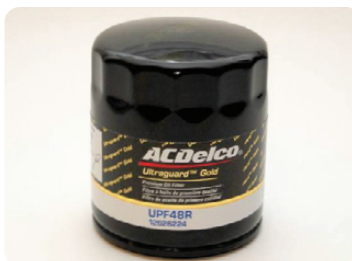
The dry sump system (RPO Z52) requires a high pressure oil filter. During an oil change, use an Ultraguard™ Gold UPF48R oil filter (part number 12626224). This filter has a higher burst strength, which is required because the oil pump produces greater volume and high system oil pressure. It is the same high pressure oil filter as used on the ZR1 and Z06 models.

TIP: The internal components are the same in both the UPF48R and PF48 oil filters. The UPF48R can be used in applications where the PF48 is specified.
